LIGHTWEIGHT EMERGENCY FLOTATION SYSTEM  
FOR THE CH-46 HELICOPTER

M. J. Reilly  
Boeing Vertol Company  
Philadelphia, Pa. 19142

FEBRUARY 1981

FINAL REPORT FOR PERIOD SEPTEMBER 1979 - JANUARY 1981

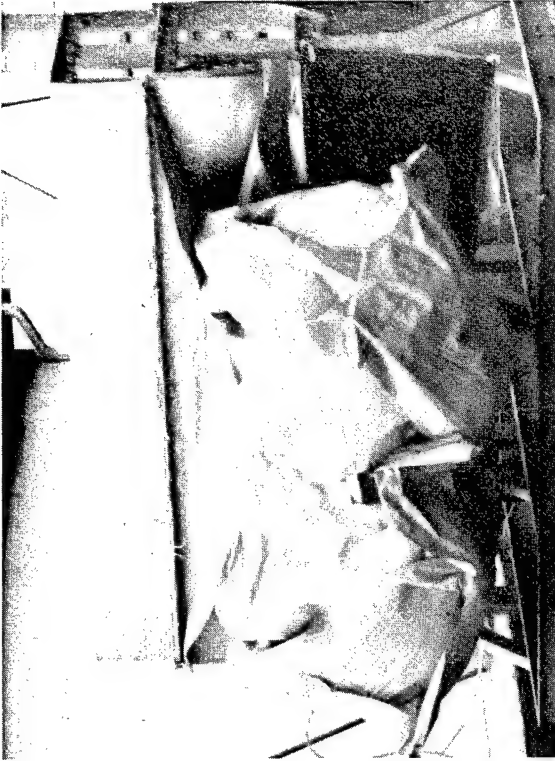
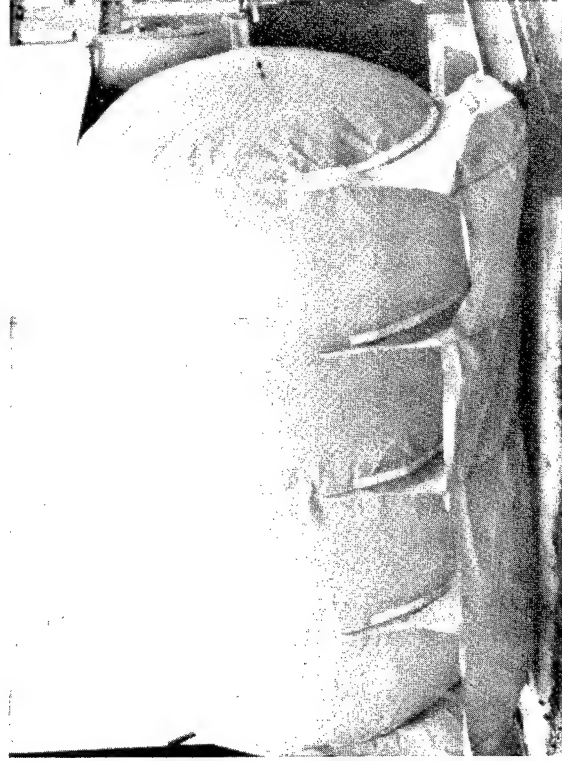
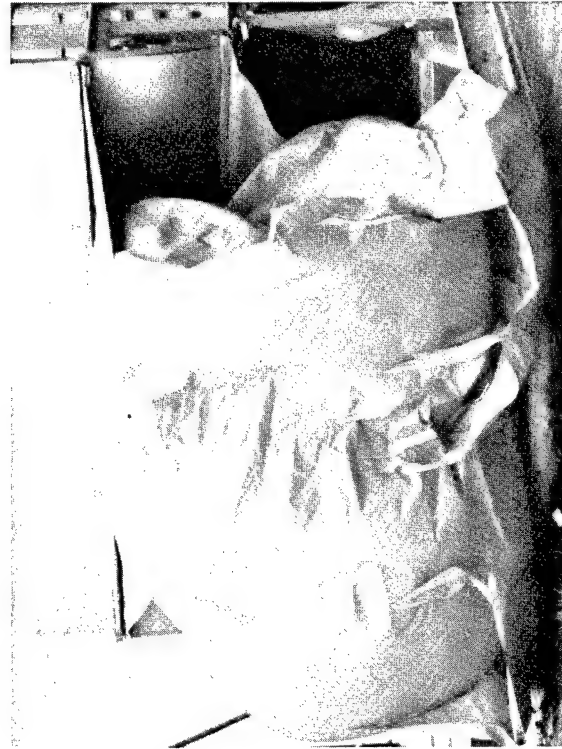
Figure 27. Prototype float inflation sequence.

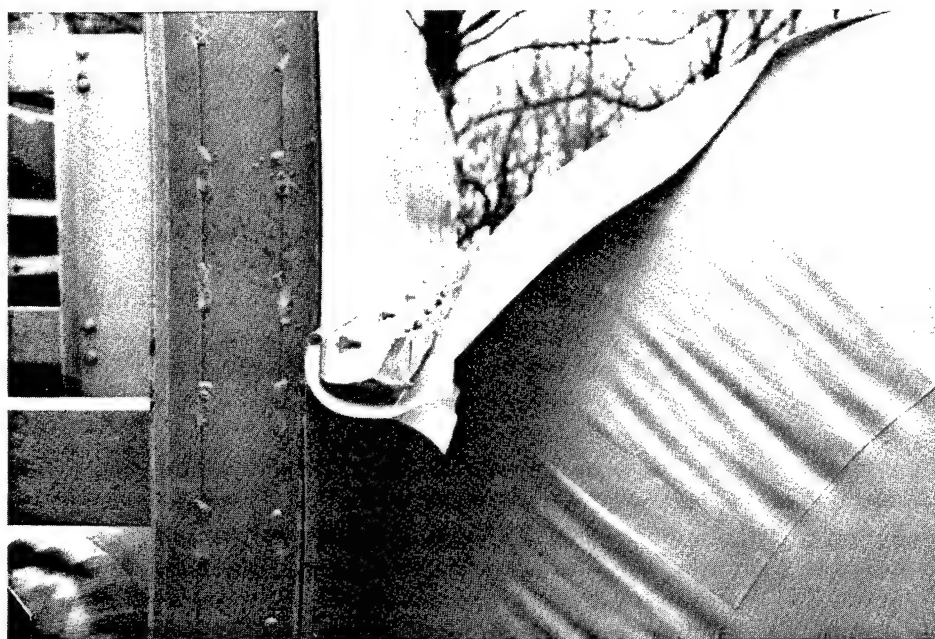
Figure 29. Frangible hinge after opening operation.

Inspection of the system showed that the frangible hinge pin functioned properly, shearing at each loop and without hinge deformation (Figure 29). The nitrogen inflation system withstood the thrust forces without displacing the cylinders or loosening the plumbing connections. At disassembly of the cylinder firing mechanism, both the primary and redundant elements in each squib were found to have fired.

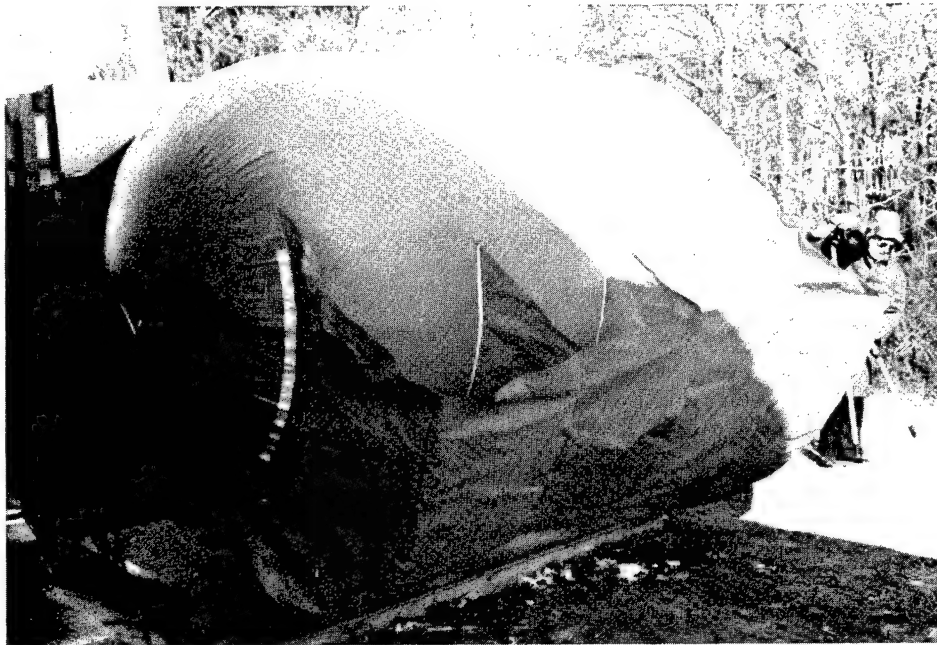
Figure 33. Test 3 inflated float at 1.2 psig.
